International Boundary Commission

UNITED STATES AND MEXICO

Placing of an Additional Monument to More Perfectly Mark
the International Boundary Line through the towns of
Caléxico, California, and Mexicali, Baja California, and the restoration of International
Monument No. 221, near
those towns.

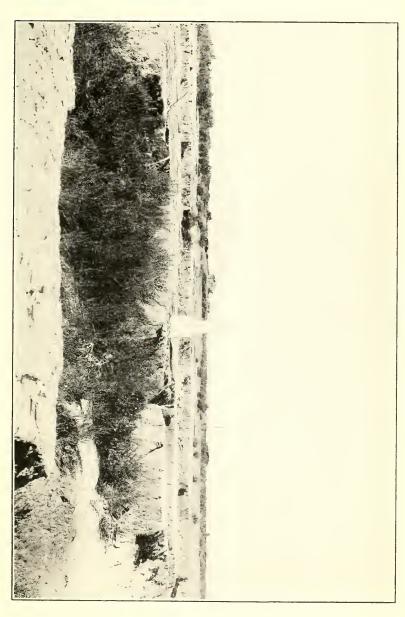
Upon examination, we found that the monument was at a safe distance (some 230 meters) from the deep channel of New River and that, although the ground around it was badly eroded, these erosions coming close to the monument, its foundation had not vet been disturbed. It appeared to us that a reasonable amount of grading around the monument would render it safe in its present position. It marks the site of monument No. IV of the survey of 1852 and is especially made for this place, having inscription plates in the base reciting that it is a restoration of the old monument, and being much larger (2 feet square at the base) than are the standard cast iron monuments. It would not have been appropriate to have erected it at any other place.

The erosion around the monument was caused as follows: In 1905 the Colorado River broke through its banks near Yuma, Arizona, following an open channel dug to the California Development Co.'s canal and formed the Colorado Crevasse. The water of the river entered the Imperial Valley and overflowed its southern end deeply. were told that the water around monument No. 221 was two meters deep and extended for many miles south and west to the mountains. In the spring of 1906 a channel from 15 to 18 meters deep and 200 meters or more wide cut back suddenly from the Salton Sink, lying many miles to the northwest. channel crossed the boundary between the monument and Caléxico, destroying in its path a good share of the town of Mexicali. The large body of water southwest of the monument rushed with tremendous velocity into this channel, deeply eroding the water-soaked soil. Fortunately, the erosion stopped just as it reached the monument, being about two meters deep at that point. This condition can never arise again, even if the Colorado Crevasse should again

(LOOKING WEST)—BFFORE REPAIRS BEGAN.

After considering these conditions, we each telegraphed to our respective Commissioner, briefly reciting what we had found and requesting authority to leave the monument where it was, grading around it so as to make it safe. This authority having been granted us, we hired teams and men and built up a fill for ten meters around the monument and also built a dam across a wash east of it, cutting a ditch so that any water which might collect back of this dam would flow into another wash further east. About 900 cubic meters of earth were moved at a cost of \$142.50, U.S. currency. One-half of this was paid by each of us.

We transmit with this report three photographs. No. 1 (looking west) shows the conditions before work commenced. No. 2 (looking west) and No. 3 (looking northeast) show the work completed. The surface of the fill was made to slope to the south so that rain water would be thrown back and not erode its northern steep slope.

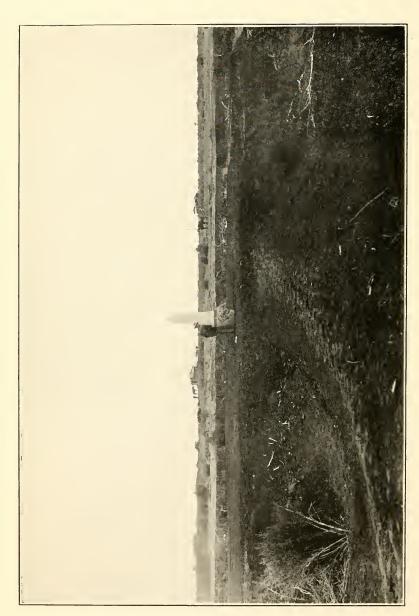
(LOOKING WEST)—AFTER FILLING WAS DONE.

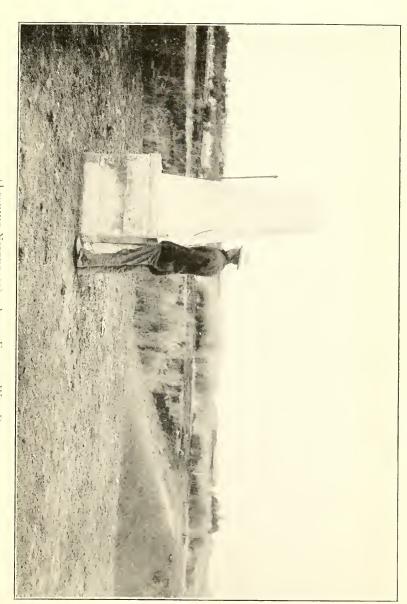
(LOOKING NORTHEAST)—AFTER FILLING WAS DONE.

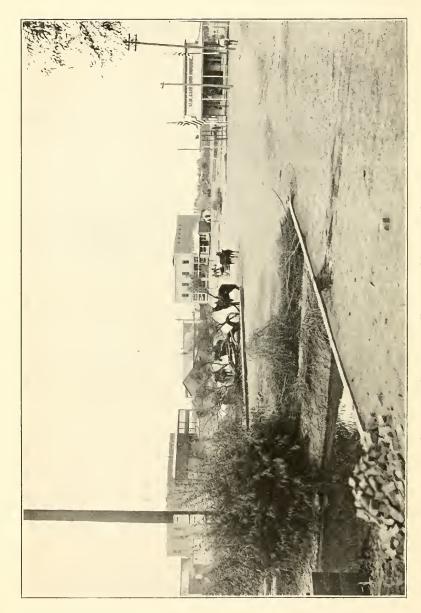
The fence, warehouse, and water tank shown in the sketch at "A" on the map.

SITE OF MONUMENT 220-A, BEFORE BASE WAS BUILT—SHOWS WAREHOUSE AND WATER TANK WITHIN 60-FOOT LIMIT.
